NASA CR-1610

**DETERMINATION OF WELDABILITY  
AND ELEVATED TEMPERATURE STABILITY  
OF REFRACTORY METAL ALLOYS**

**IV - Post Weld Annealing Studies of T-111**

*Prepared by*  
WESTINGHOUSE ASTRONUCLEAR LABORATORY  
Pittsburgh, Pa. 15236  
*for*

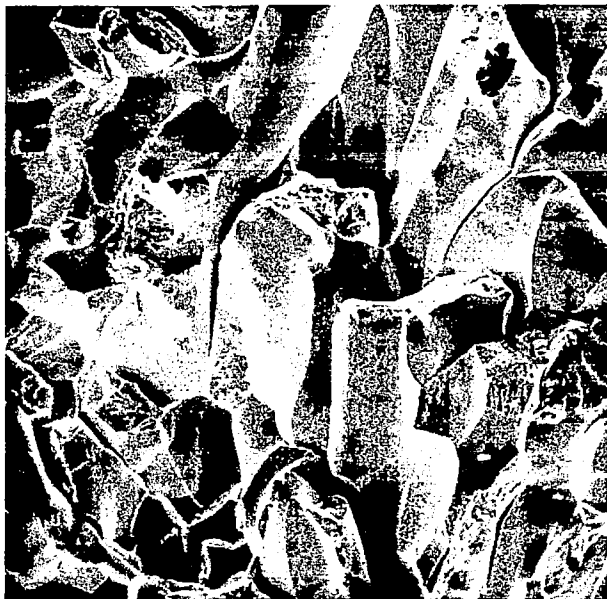
FIGURE 2 - Scanning Electron Fractographs of T-111 Weld Specimen. Fractured by Bend Testing Following Aging 5000 Hours at 1800°F. Annealed 1 Hour at 2400°F Prior to Aging.

- The primary fracture mode was by grain boundary tearing rather than by transgranular cleavage. Again, this indicates that the aging behavior cannot be described as a classic shift in the ductile-to-brittle transition temperature. The scanning electron fractographs of Figure 2 show the typical grain boundary fracture mode of aged T-111 weld metal.

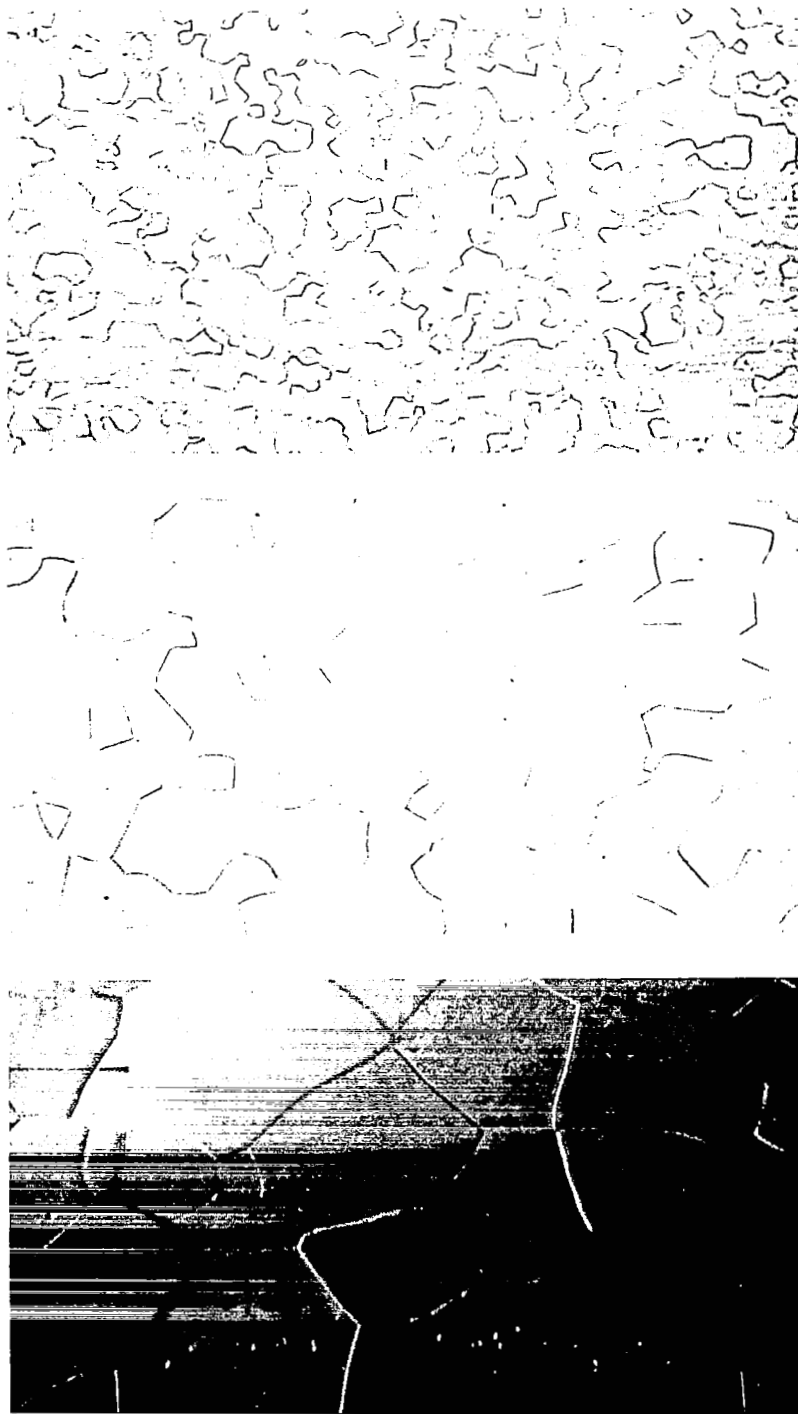
FIGURE 13 - Microstructure of T-111 Base Metal, As-Received. Top, 200X. Middle, 500X. Bottom 1500X. Met. 16,697.

Zone 4 displays a response to welding which is somewhat unique, Figure 12. A precipitation occurs along what appear to be flow lines observed as a ghost structure in T-111. This ghost structure is visible in the 200X base metal photomicrograph, Figure 13. No explanation has been developed for this ghost structure although it is believed to be flow lines resulting from incomplete homogenization. This structure is usually observed in Ta based alloys and frequently in Cb based alloys. The precipitation appears then to be a relatively low temperature response associated with constitutional segregation. This is an interesting observation particularly since T-111 aging occurs at relatively low temperatures and, as will be shown shortly, the aging is accomplished by weld and HAZ precipitation in patterns controlled by constitutional segregation. The weld zone is single phase as-welded, Figure 9. This is likewise the case at the weld interface for weld and HAZ, Figure 10, and in the HAZ proper, Figure 11, and in the base metal, Figure 13. A very modest amount of precipitate is observed along the ghost structure in the base metal. This appears to be the precipitate which develops more fully during welding at the edge of the HAZ as shown in Figure 13.

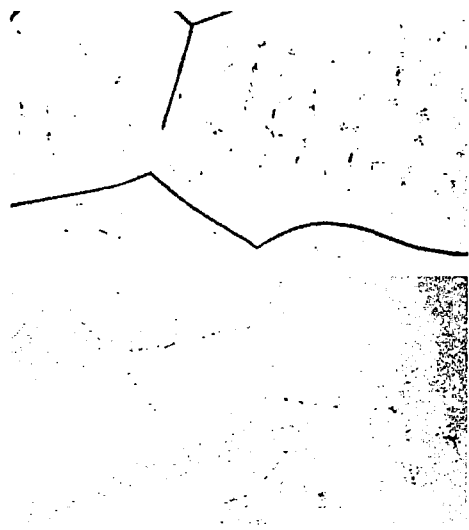
<p>Weld 500X ( 16,701 )</p> <p>BDBTT + 125°F</p> <p>HAZ 500X ( 16,706 )</p>
<p>PWA 1 Hr. - 2400°F</p>	<p>BDBTT - 50°F to + 25°F</p> <p>( 16,702 and 16,707 )</p>
<p>PWA 1 Hr. - 2600°F</p>	<p>BDBTT + 150°F</p> <p>( 16,704 and 16,709 )</p>
<p>PWA 1 Hr. - 3000°F</p>

<p>Weld 500X</p> <p>BDBTT - 100°F</p> <p>( 16,705 )</p>

FIGURE 19 - Microstructure of T-111 Aged 1000 Hours at 2100°F. Post Weld Annealed as Indicated.
